Viewpoint 10: View Facing West From Connelly Road

Hecate Energy
Shepherd's Run Solar

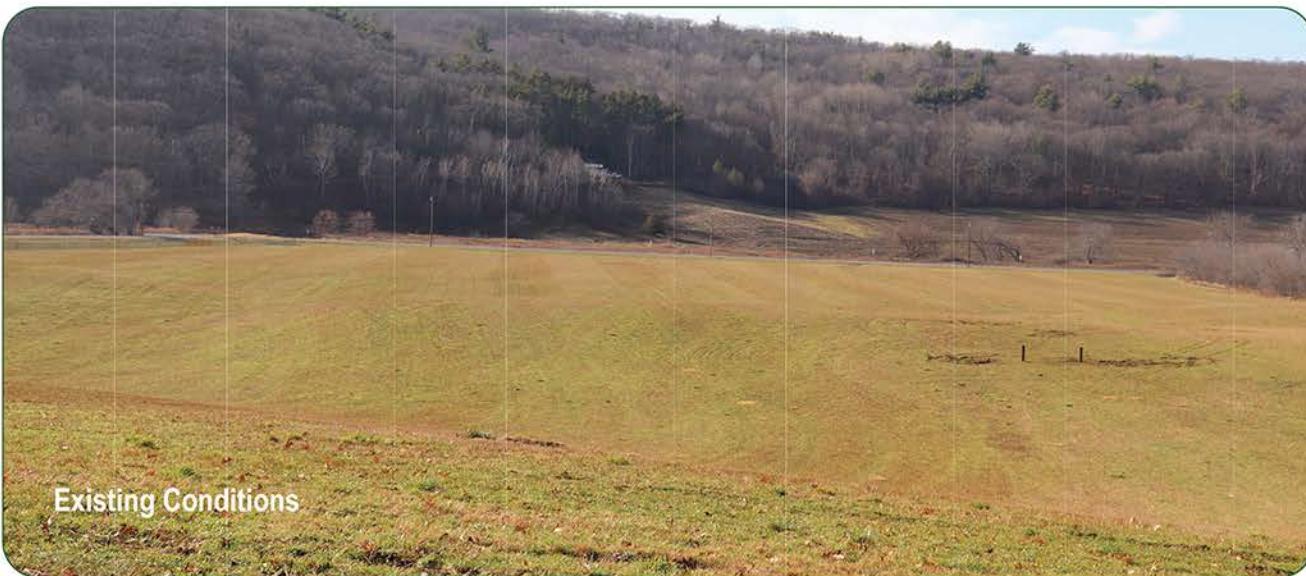
Existing Conditions

Viewpoint	10
Time	1:26pm
Date	12/3/2020
Weather Conditions	Partly cloudy
Direction	West
Latitude	42°9'32.15"N
Longitude	73°33'57.02"W
Photo Location	Connelly Road
Distance to Panels	222ft

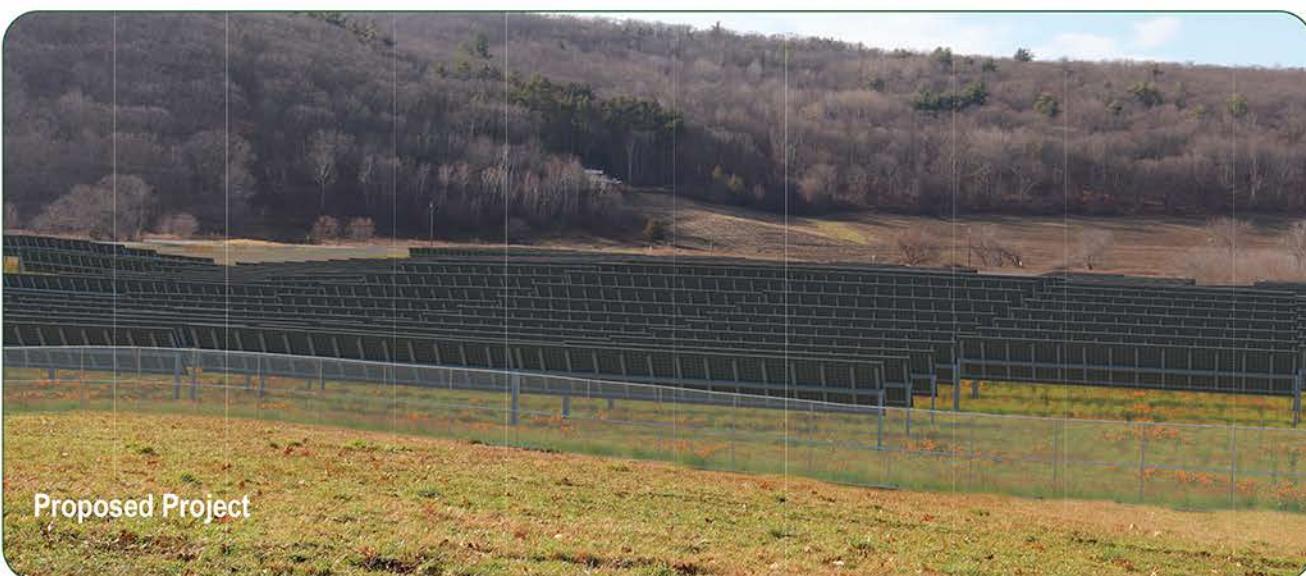
Proposed Project

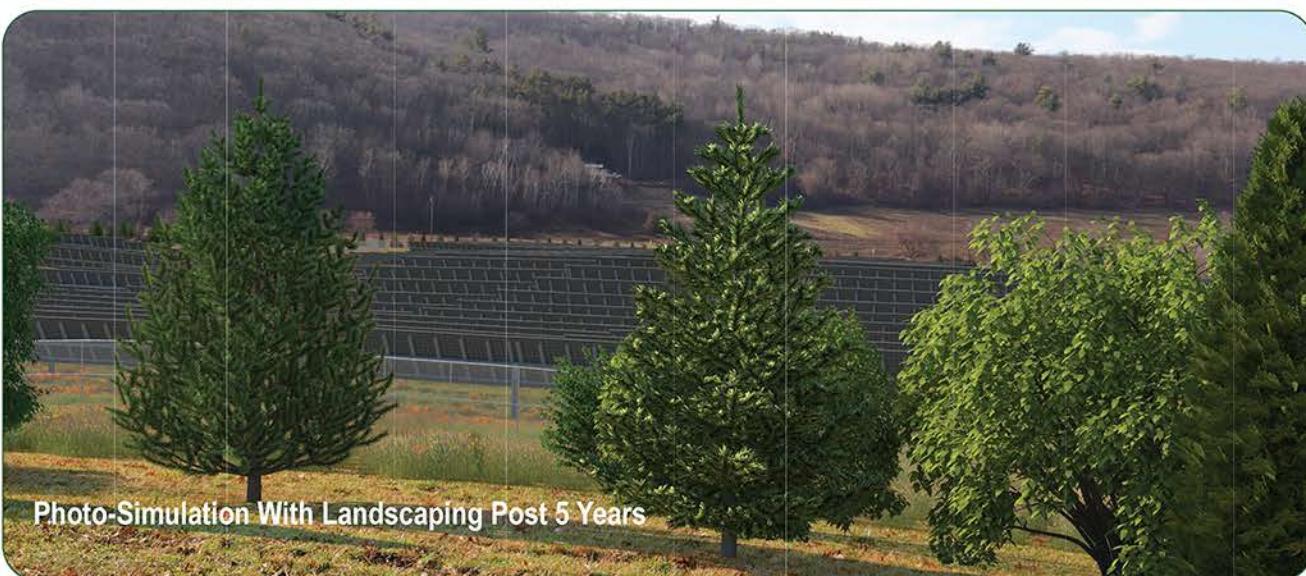
Photo-Simulation With Landscaping Post 5 Years

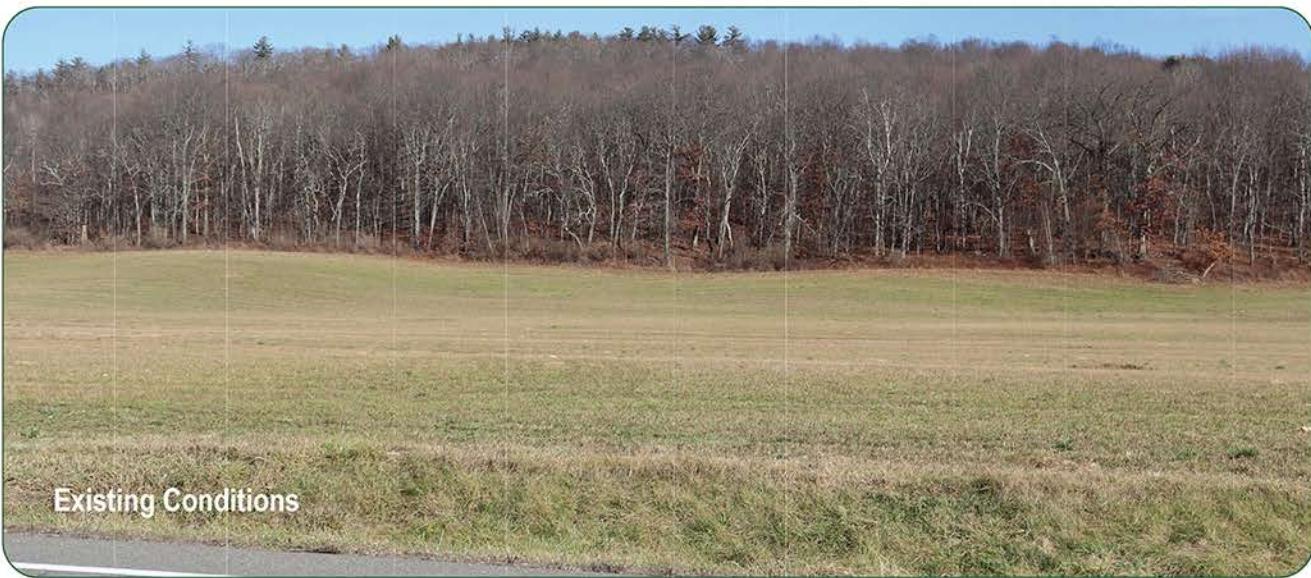
Existing Conditions

Viewpoint 11: View Facing East From Route 7

Viewpoint	11
Time	1:00pm
Date	12/3/2020
Weather Conditions	Partly cloudy
Direction	East
Latitude	42°9'37.84"N
Longitude	73°34'24.71"W
Photo Location	Route 7
Distance to Panels	239ft

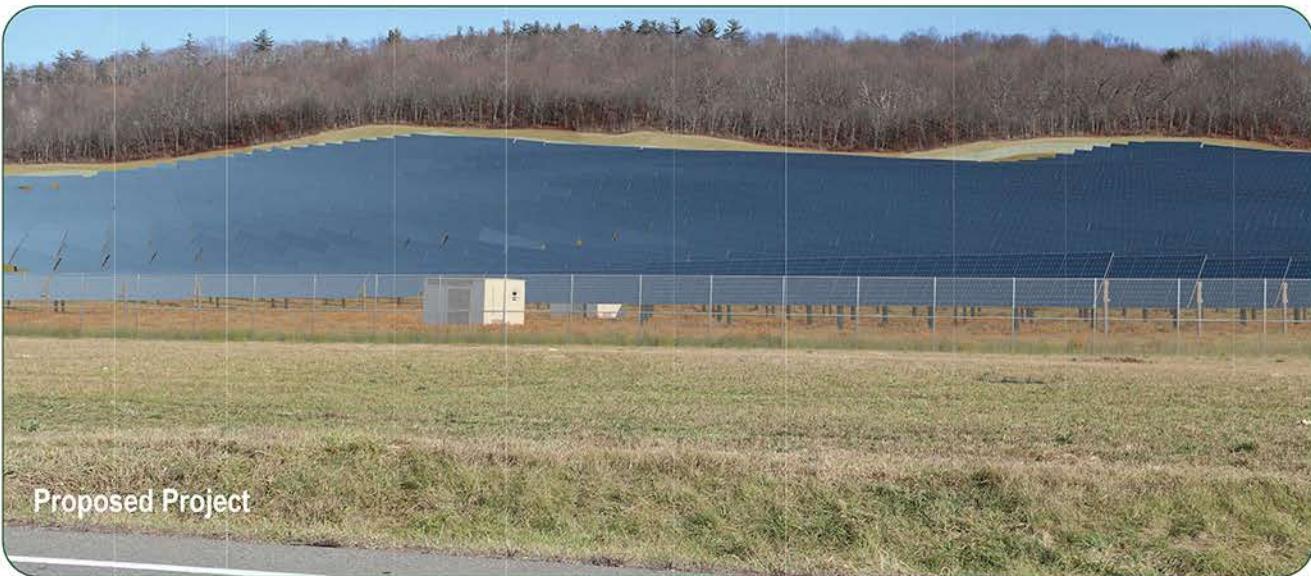
Proposed Project

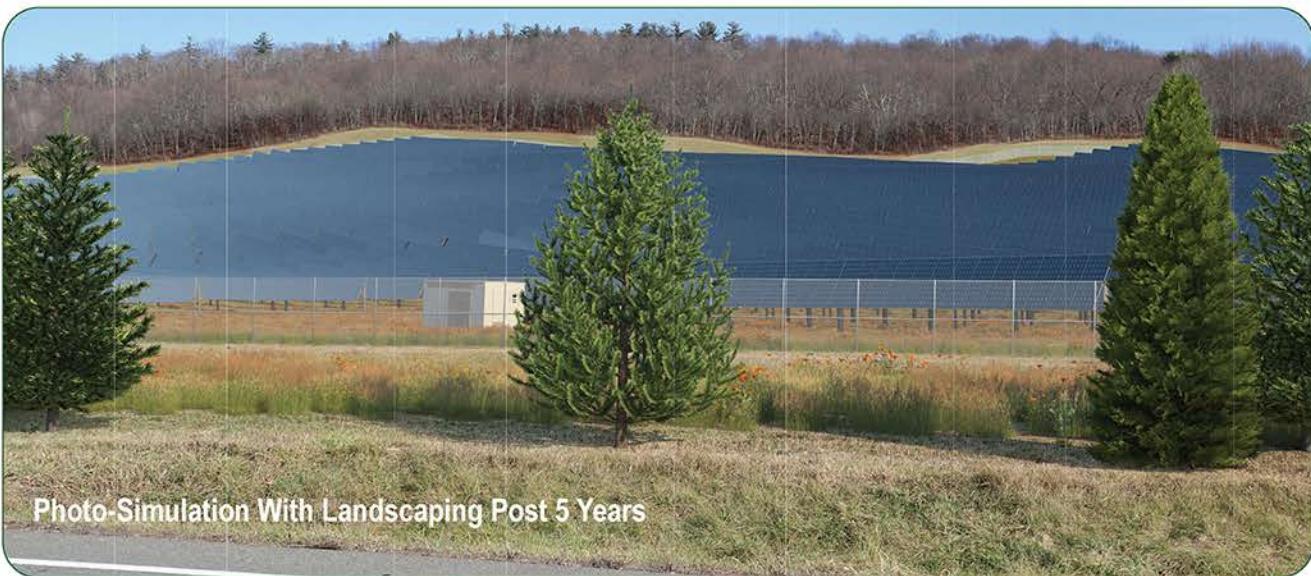
Photo-Simulation With Landscaping Post 5 Years

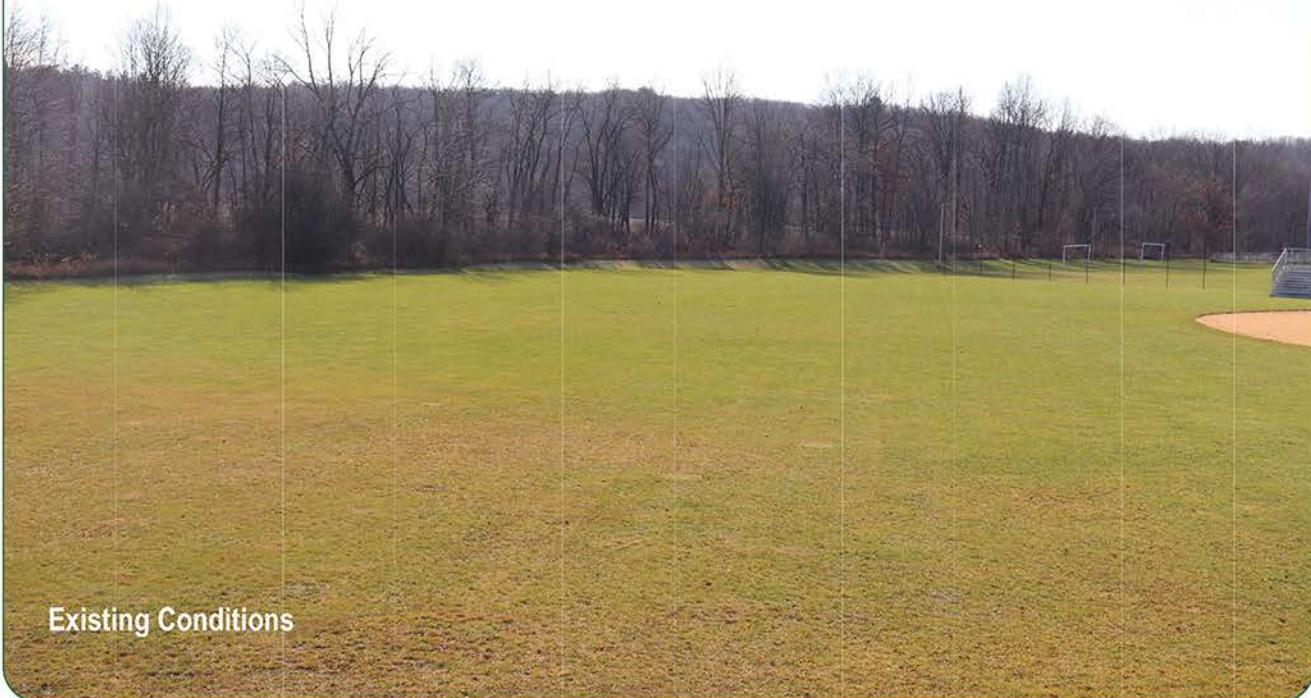
Existing Conditions

Viewpoint 30: View Facing East From Route 11A

Viewpoint	30
Time	11:27am
Date	12/3/2020
Weather Conditions	Partly cloudy
Direction	East
Latitude	42°10'29.96"N
Longitude	73°35'46.54"W
Photo Location	Route 11A
Distance to Panels	647ft

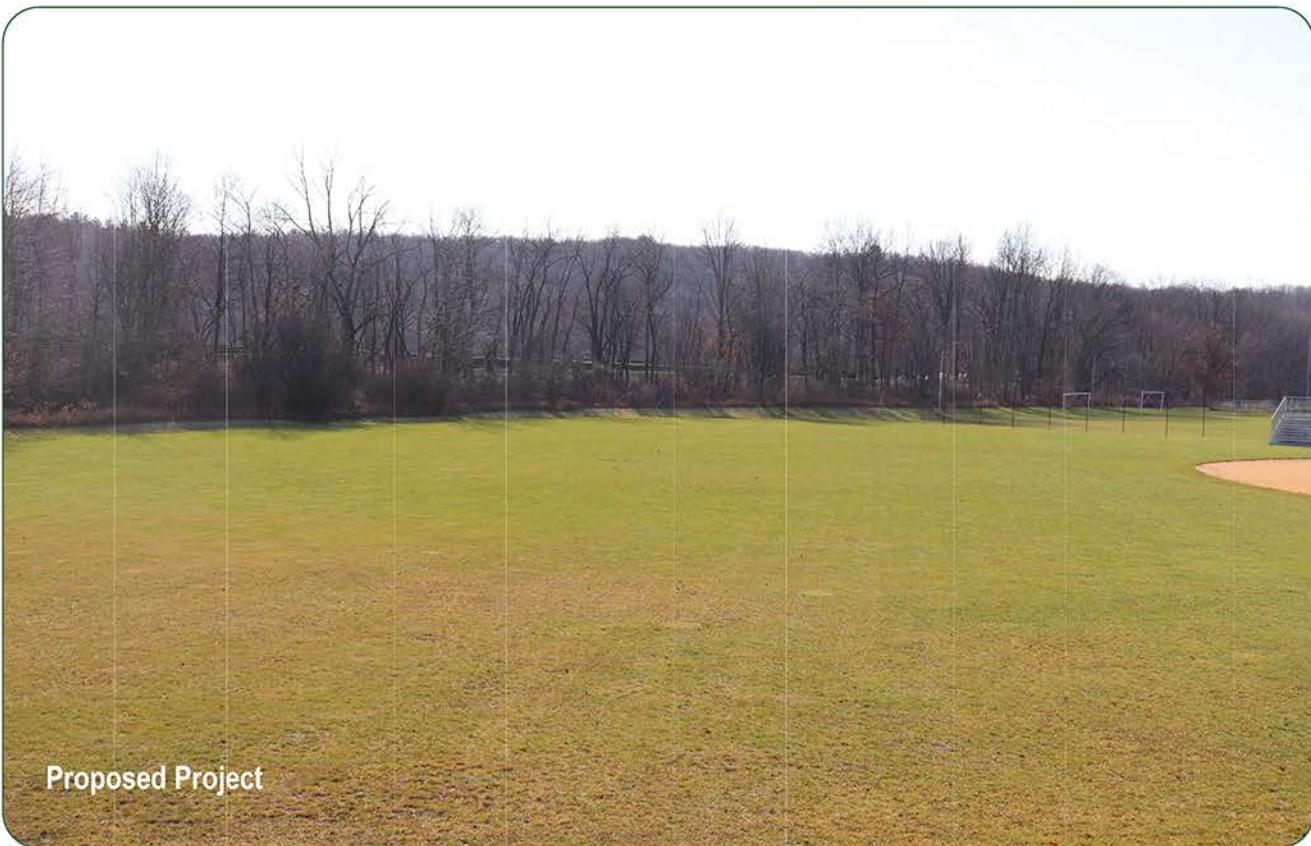
Proposed Project

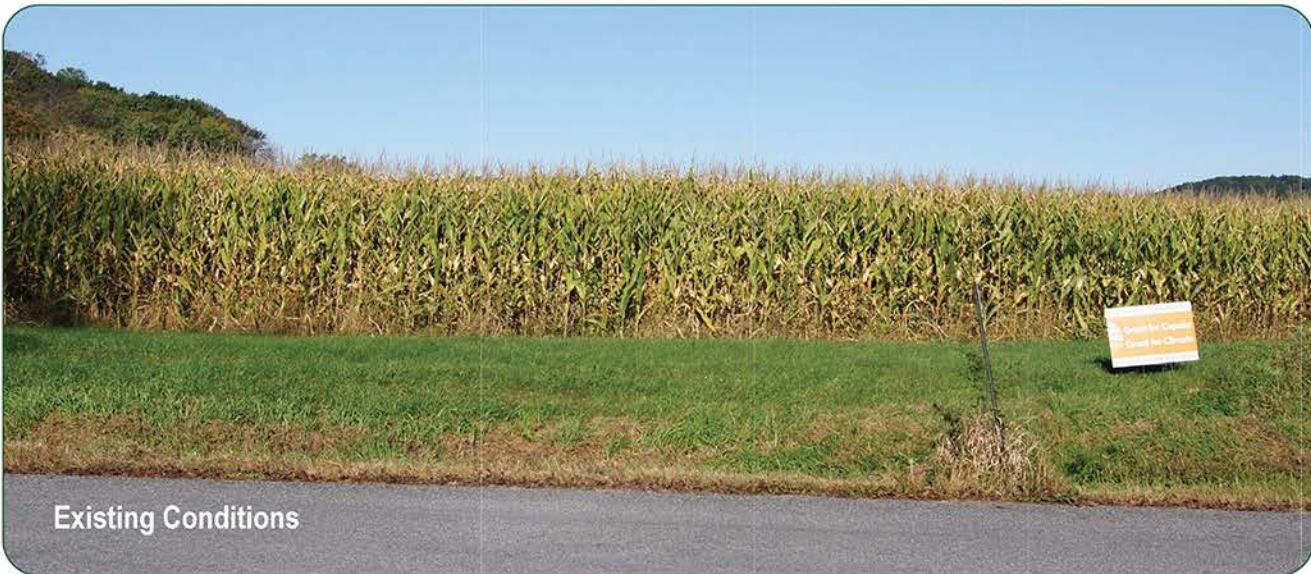
Existing Conditions

Viewpoint 51: View Facing West From Birch Hill Road

Viewpoint	51
Time	8:16am
Date	9/29/2021
Weather Conditions	Sunny
Direction	West
Latitude	42°9'58.44"N
Longitude	73°34'53.13"W
Photo Location	Birch Hill Road
Distance to Panels	249ft

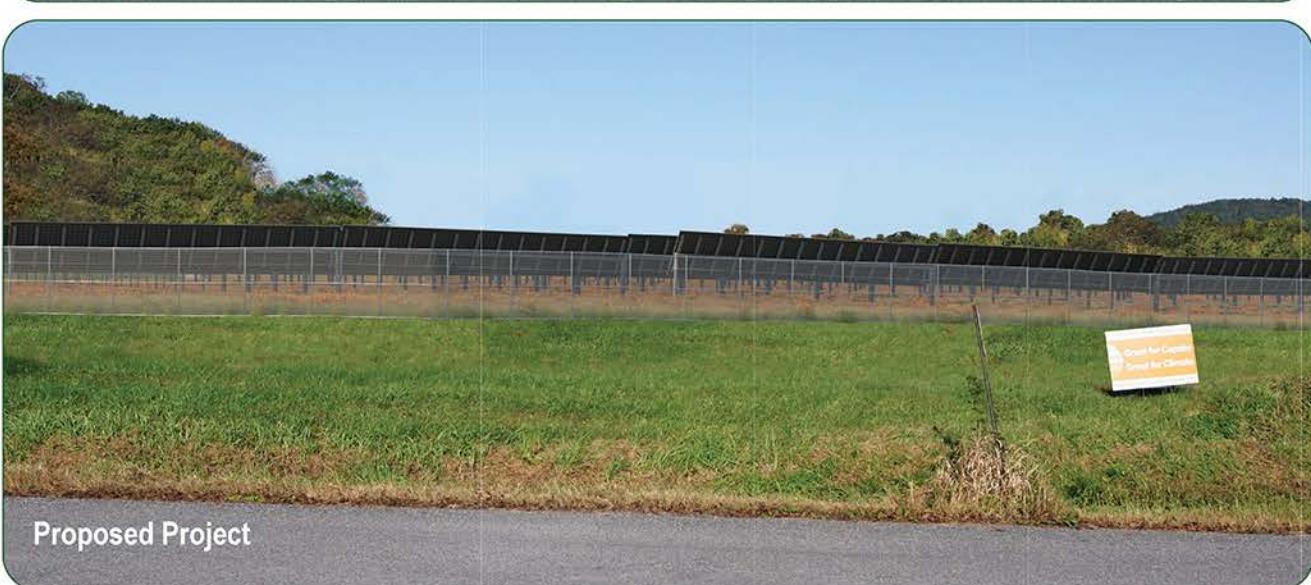
Proposed Project

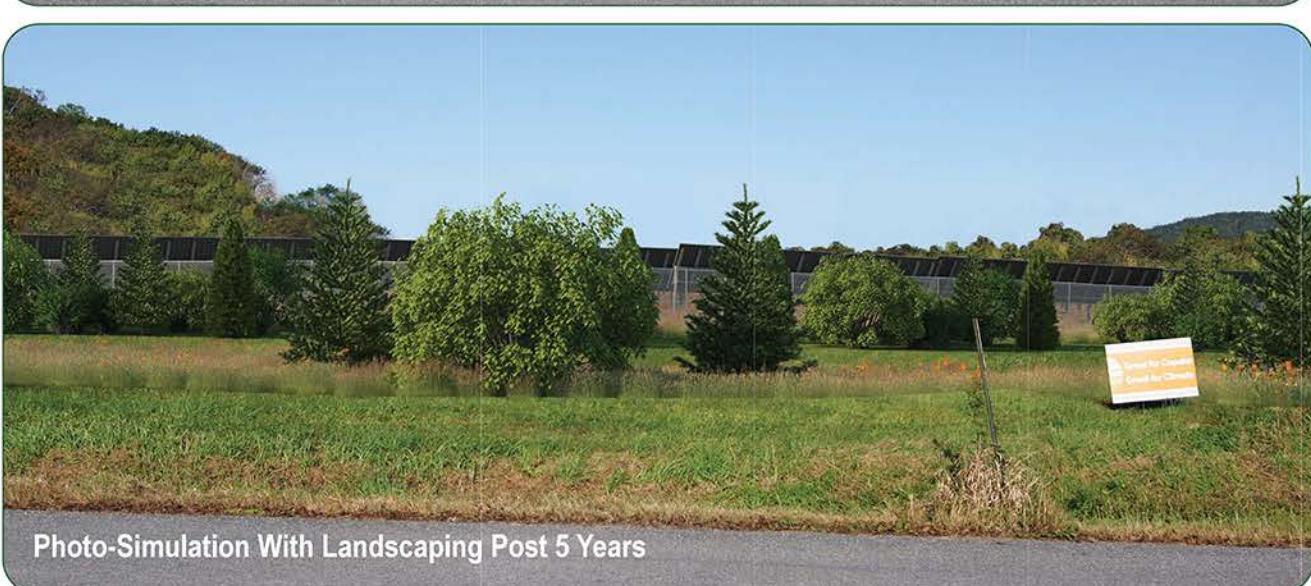
Photo-Simulation With Landscaping Post 5 Years

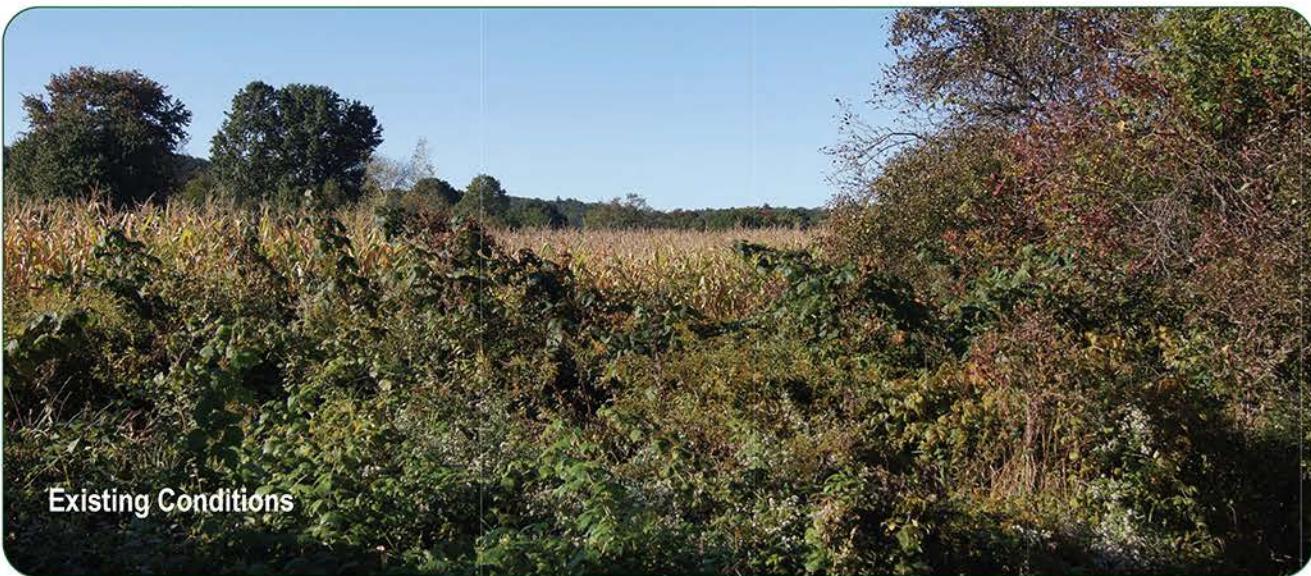
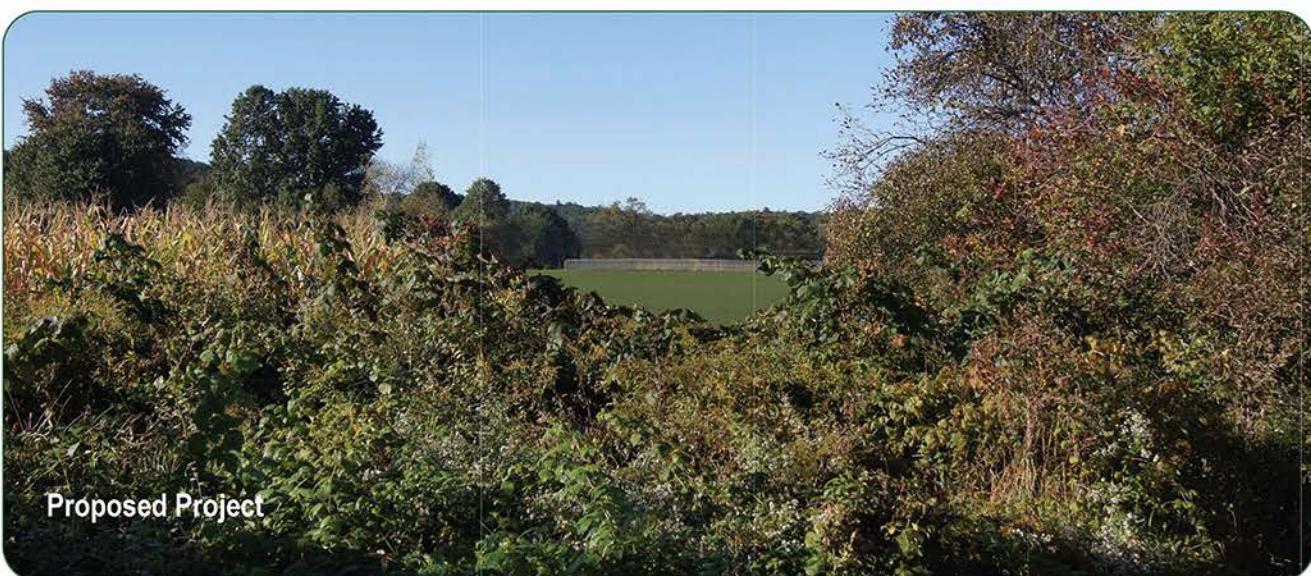
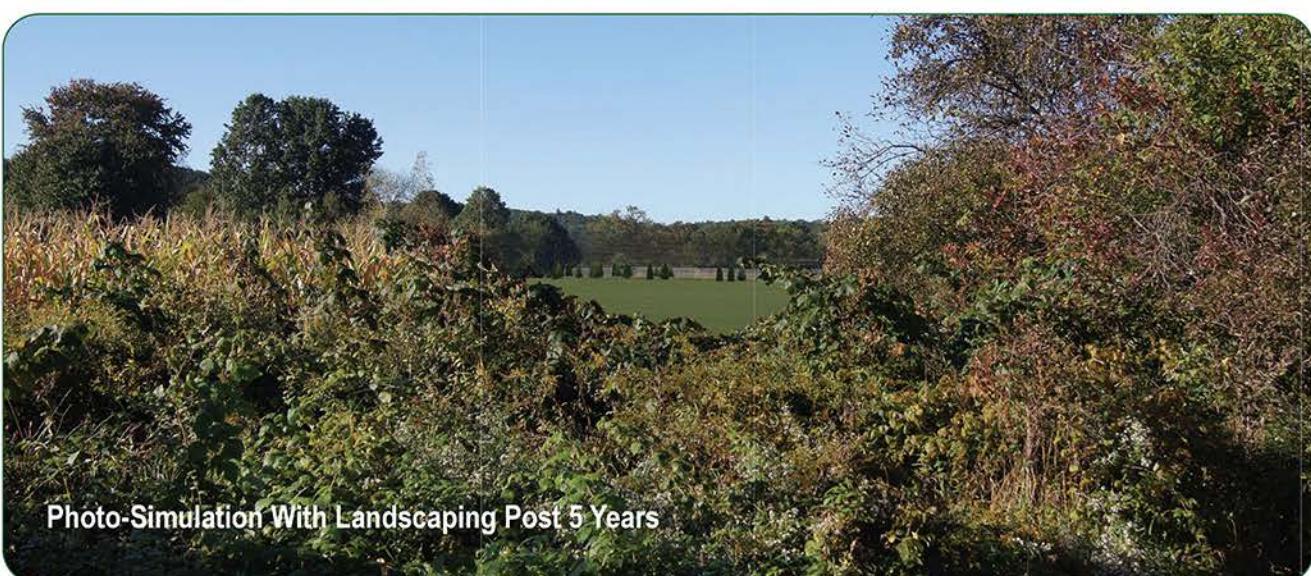
Viewpoint 55: View Facing Southwest From Railroad Lane

Viewpoint	55
Time	8:02am
Date	9/29/2021
Weather Conditions	Sunny
Direction	Southwest
Latitude	42°10'36.38"N
Longitude	73°34'19.91"W
Photo Location	Railroad Lane
Distance to Panels	1148ft
